Kathmandu | Nepal

DISASTER RELIEF PROJECT

Monthly Report - July 2015

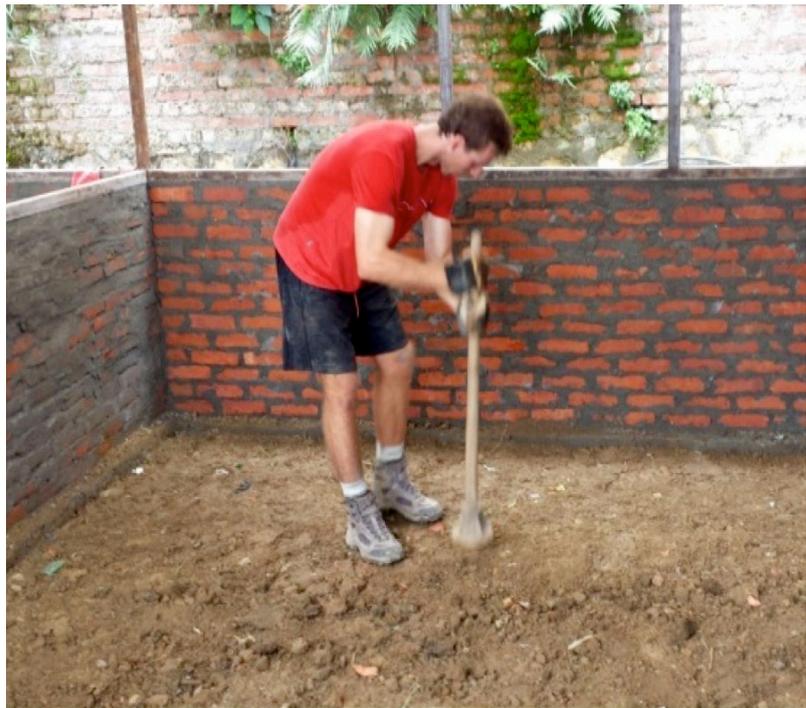
A volunteer uses a tamper to level the floor

Before laying the floor blocks, we needed to make sure that the ground was flat and even. Working in groups of three, volunteers used shovels to remove excess clay and then evenly distributed the remaining dirt throughout the classroom floor. The floors were then flattened using tampers.

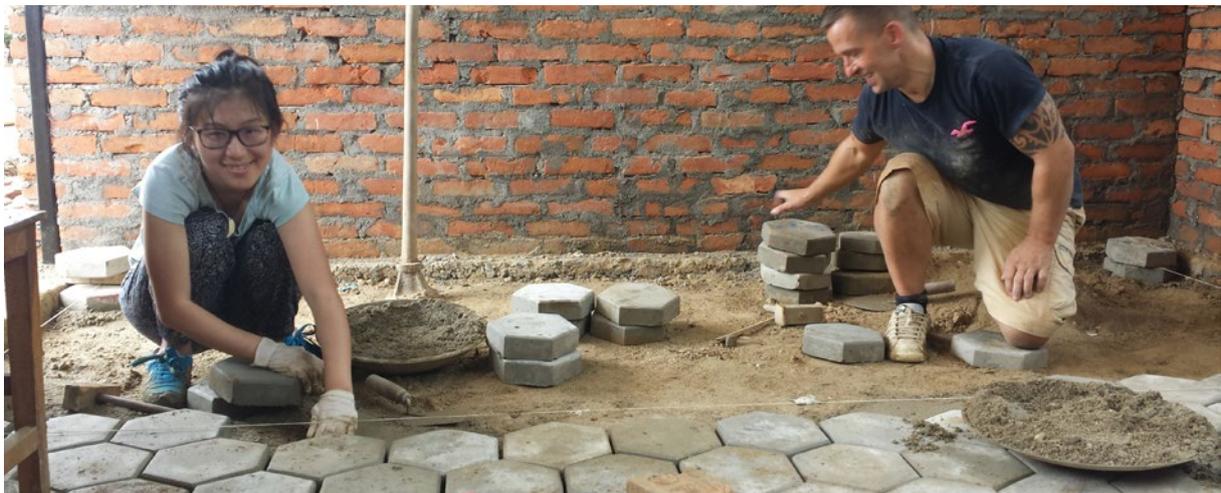
Volunteers laying the floor blocks

Under the guidance of the local workers, volunteers applied a layer of sand before placing the floor blocks. A string was tied from one side of the room to the other as a reference for what height each floor block should have been. This also helped to level the ground much better.

Once the job of laying the floor blocks was finished, the gaps around the edge of the floor were filled with concrete so that the blocks stayed in place.

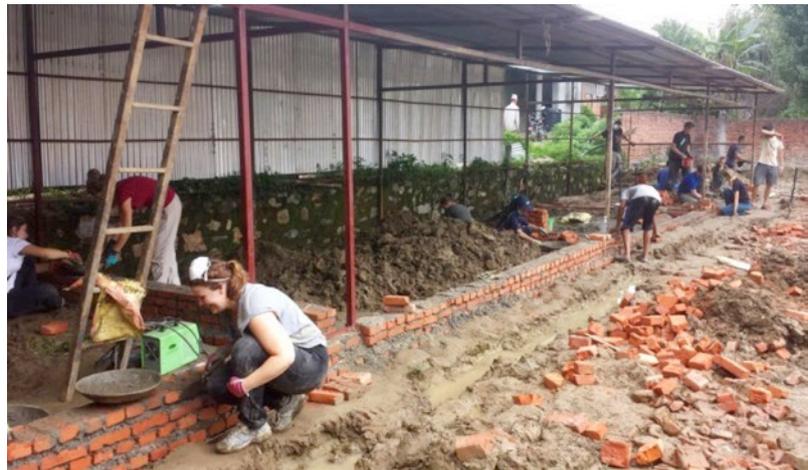
Completing the brickwork that will contain the raised 9" floors

Progress on the structure's foundations had previously been inhibited by the monsoon rain, but with unexpected clear skies overhead we seized the opportunity to dig foundations and begin some brickwork. In order to combat the inevitable monsoons, the floors of this structure needed to be raised above ground-level. To accommodate this raised floor, we first had to complete brickwork that would hold six inches of dirt above ground-level and then a further three inches of concrete.
